UNITED STATES MARINE CORPS
MARINE CORPS BASE
CAMP LEJEUNE, NORTH CAROLINA 28542

Subj: Training Incidents involving Air and Artillery Mishaps

SIGNIFICANT KNOWN RANGE INCIDENTS

GRAPHIC ILLUSTRATION OF REASON REPORTED ARTILLERY INCIDENTS INVOLVE
ALMOST EXCLUSIVELY OP'S 2 and 3/LYMAN ROAD

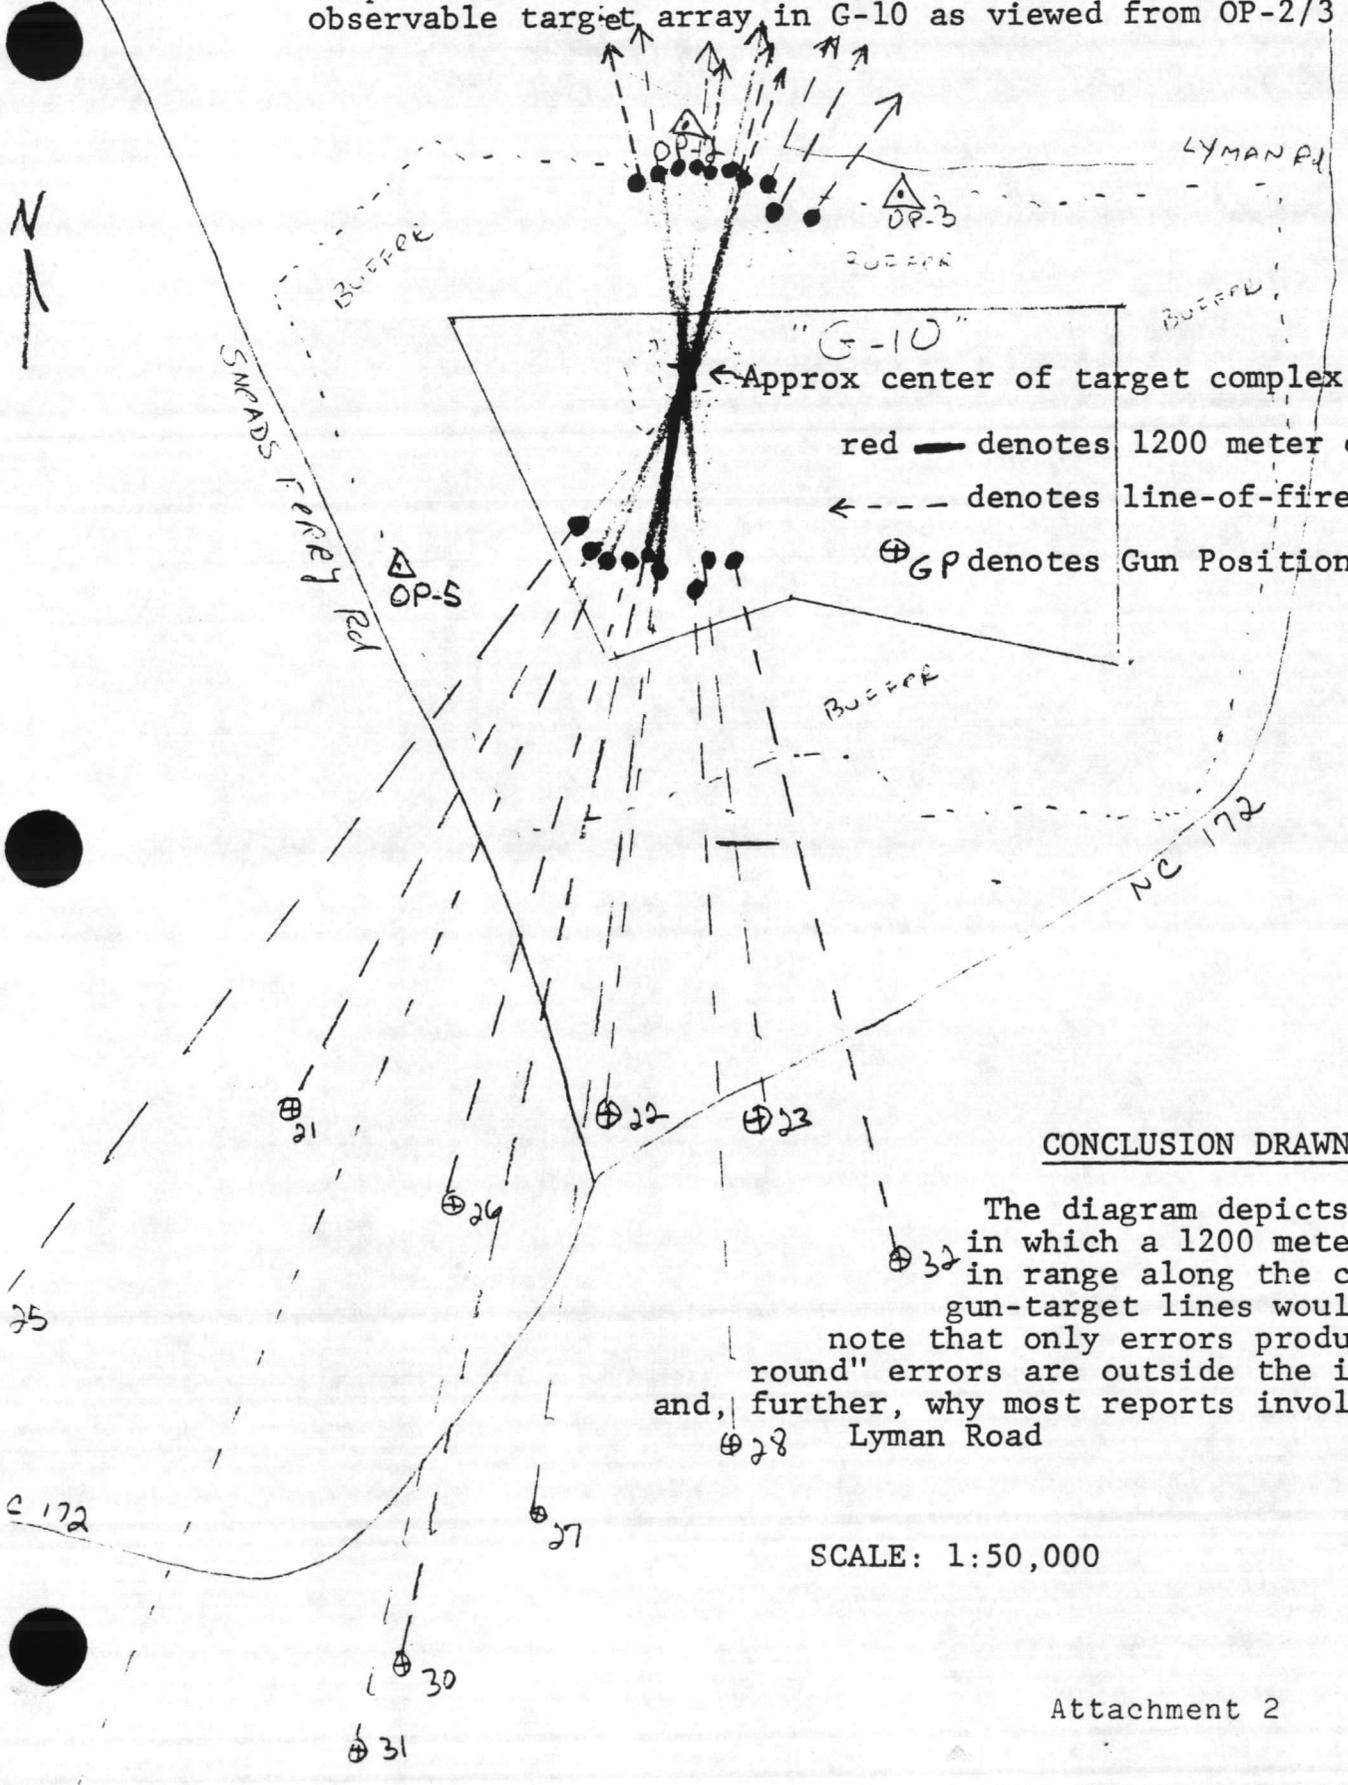
ASSUMPTION: That an error is made which produces a 1200 meter short/over rd from the Gun Positions depicted; further, that the data for the weapons is calculated for a point in the center of the major observable target array in G-10 as viewed from OP-2/3

The diagram depicts the area in which a 1200 meter error in range along the common gun-target lines would impact: note that only errors producing "long round" errors are outside the impact area, and, further, why most reports involve OP 2-3/ Lyman Road

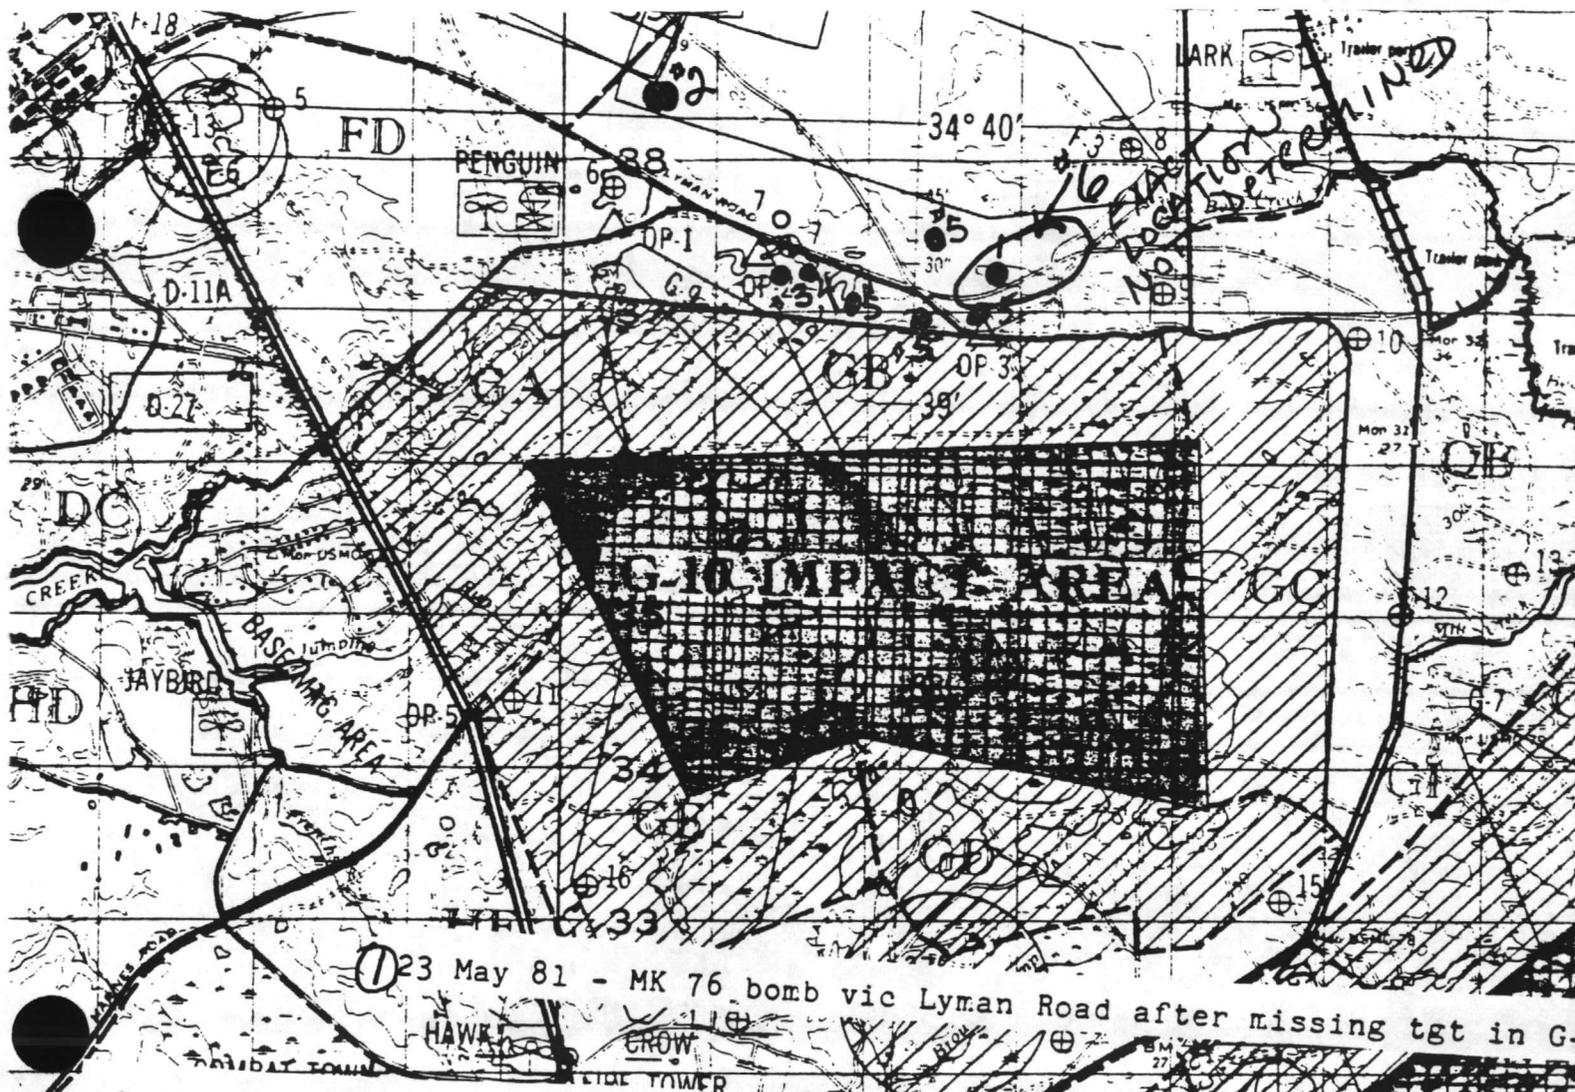
"AIR INCIDENTS"

① 23 May 81 - MK 76 bomb vic Lyman Road after missing tgt in G-10

② 16 Sep 81 - TOW missile fired into G-10 from AH-1T hovering over OP-5 goes out of control and impacts vic GC 903383 (300m north of Lyman Rd). "Uncommanded, ballistic flight, several others also missed target but landed in buffer zone..." HMA-269 investigates. Suspected faulty missiles.

③ 10 Dec 81 - 2d MAW drops MK 76 practice bomb vic OP-2. 1 Marine sustain leg injury. Pilot error.

④ 21 Oct 82 - A-6 RABFAC mission (VMA-332) into G-10 drops inert 500 lb SNAKEYE which impacts OP-2 (Lyman Road close to 81mm mortar plt from 1/2. This incident was attributed to malfunction of the solenoid which deploys the high drag bomb fins allowing it to "go clean" and it went approx 1700 meters.

⑤ 13 Jan 83 - A-6 RABFAC mission misdrops 5-6 MK 76 practice bombs vic OPs 2 and 3. Suspected computer malfunction. No injuries VMA (AW) 331

⑥ 3 May 83 - During "Exercise Solid Shield 83" Navy A-6 from VA-75 (Carrier Based) misdrops 4 MK 76 bombs vic Lyman Road under investigation COMCARGRU-8.

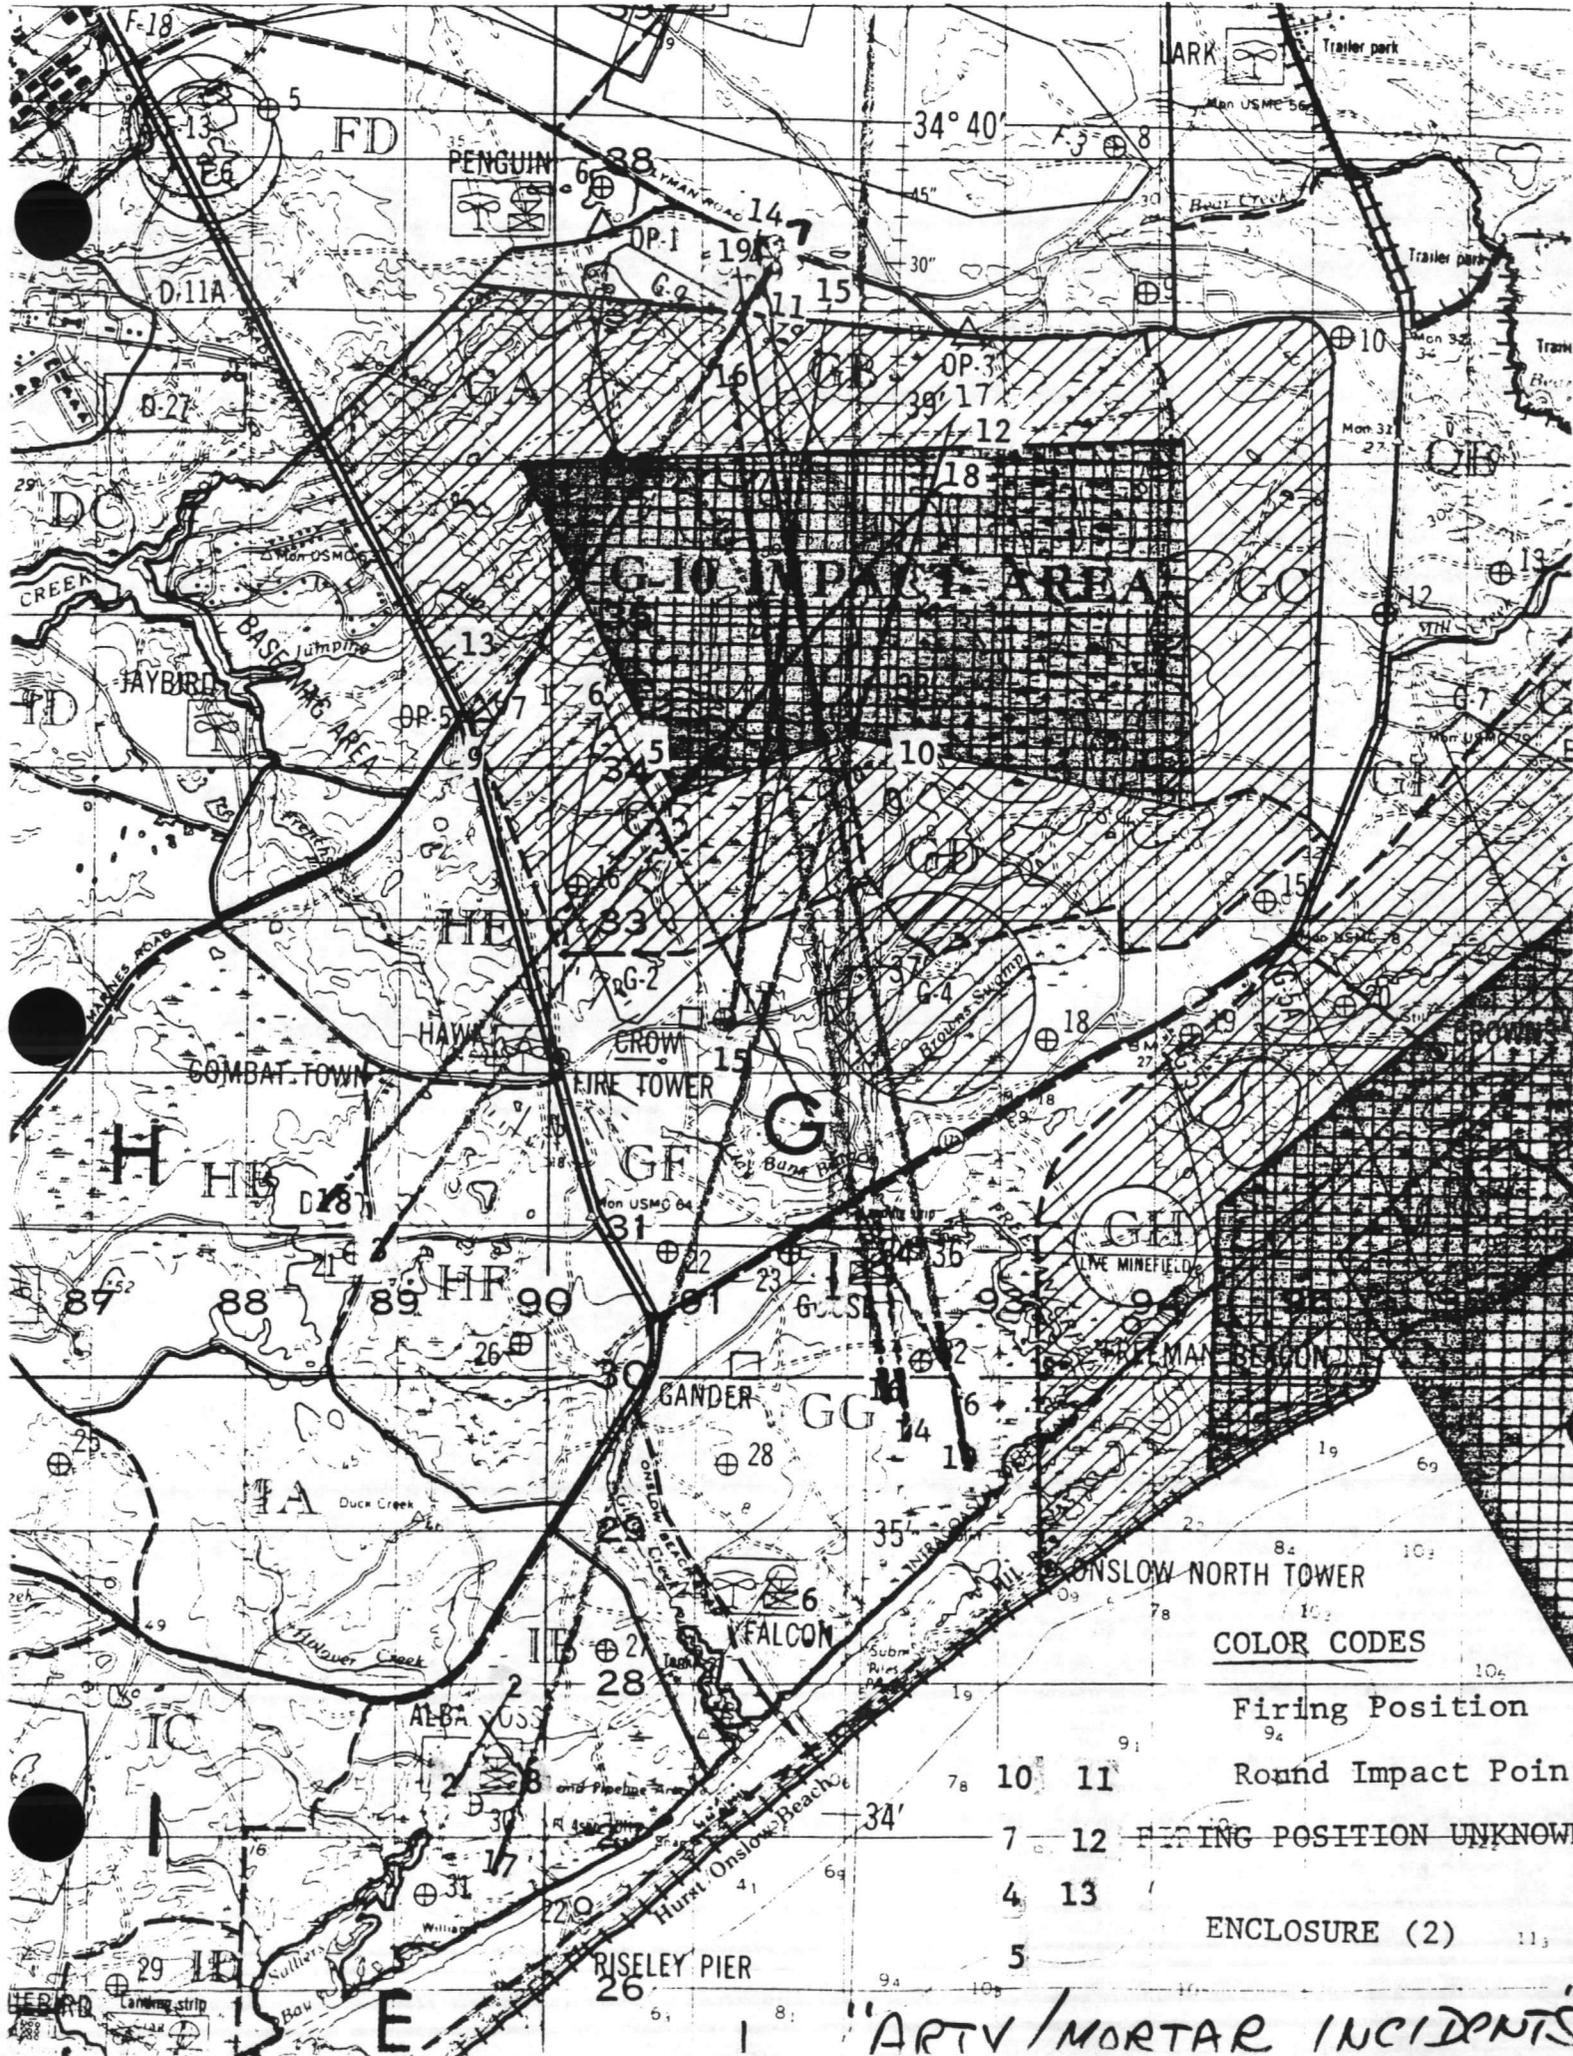
1 8: "ARTV / MORTAR INCIDENTS"

1. 10 Feb 79 - "B" Battery 1/10 fired 105mm proj from gun position 23 (919307) fired "Chg 7" instead of "Chg 4". Round never found, likely point was vic GC 917402.

2. 20 Jun 79 - (GP 30) M 4/10 has premature "Close Aboard". 1968 ammo lot. Suspected defective fuse. No injuries.
3. 23 Jun 79 - C 1/10 fires short round from GP-21 which impacts vic 907337 (Suspected premature time fuse).

4. 24 Jun 79 - A 1/10 fires out, round impacts in buffer zone vic GC 913370 (Vic OP-2). Firing position not given.
5. 9 Jul 79 - OP-5 reports artillery short round from GP-21 impacted vic GC 907343. Section chief error: relieved of duties. Unit not reported except as "155mm".

6. 29 Aug 79 - E 2/10 (GP 28) and D 2/10 (GP 32) placed in check fire after OP reports both an impact and air burst about 800 meters from OP-5
7. 10 Feb 81 - 2 8" artillery V.T. rounds impact vic TWSEAS/OP-5 fired by 5/10. Cause was 100% elevation error on Gun #3.

8. 21 Nov 81 - Defective fuse (VT) goes off approx 200 meters from gun at GP 30. Fuze lot suspended. No damage/injuries. Unit of 10th Mar unknown.
9. 14 Sep 82 - Wpns 1/6 makes 720% plotting error firing 81mm mortars from vic OP-2. Rounds landed vic Sneads Ferry Road/OP-5. No injuries.

10. 15 Sep 82 - F 2/10 fires out of safe 1 round impacts in buffer zone vic 921341. No gun position given.
11. 16 Sep 82 - Plt cdr Wpns 1/6 mortars reports dud arty round landed forward of their position vic OP-2. EOD unable to identify/locate round.

12. 17 Sep 82 - OP-3/D 2/10 reports arty round (WP) in buffer zone vic GC 929362.
13. 17 Sep 82 - OP-5/Wpns 2/6 reports arty round in buffer zone vic GC 893348. EOD and 10th Mar personnel located site of airburst, but could not positively determine the caliber (155 or 105mm).

14. 6 Oct 82 - ("Slovic Case") I 3/10 fired two 155 rounds with charge error from GP 32 which impacted just north Lyman Rd immediately across from OP-2 killing dependent wife in POV and extensive property damage to govt and civ vehicles in OP-2 parking lot.

15. 17 Jun 82 - B 1/10 (GP 17) fires out of safe. Charge error. Rounds landed vic 917371/OP-2.
16. 28 Jun 82 - L 2/10 (GP 32) fires 2 rounds impacting in buffer zone vic 911365. Gunnery error suspected; correct chg

17. 13 Jul 82 - Arty round impacts approx 300 meters south of OP-3. Two arty units hit: B 1/14 (GP 30); C 1/10 (GP 15). Round caused damage to POV driving down Lyman Rd belonging to LCpl MOFFITT (Maint En, FSSG). Efforts to determine which unit was responsible. Crater could not be located for analysis due to heavy underbrush/swamp.

18. 5 May 83 - G 3/10 firing from GP-21. FO Team at OP-3 reports rounds exploding vic G-10, seconds later a piece of low velocity shrapnel lands approx 5 feet from LCpl BUTCHER (at OP-3) Best estimate is that the rounds were correctly fired into G-10 and shrapnel was not caused by misfired rounds.

19. 22 Jun 83 - "I" 5/10 (GP 32) fires 155mm round which is observed to impact and ricochet vic OP-2 across Lyman Road. Crater analysis performed, round cannot be located. Gunnery data appears correct: Possible double ricochet. Under investigation.
